**Flood Control Project Maintenance
Levee Inspections**

Maintenance Issue Types Only, Levee Inspection Report By Mile - Fall 2018

Sutter Maintenance Yard Maintenance Area 0013

Waterway	Bank	Unit Miles	Inspection Start/End	Inspector
Unit No. 01 Cherokee Canal	Right	18.19	10/31/2018 10/31/2018	Bob Duffey

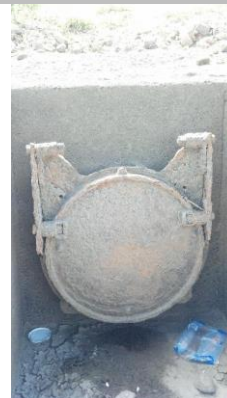
Photo 3 of 3 : UCIP_FA_2018_52170_67461.jpg

Item	DWR UCIP LMA Responsibility			39.362378 °	39.362378 °	
				-121.867350 °	-121.867350 °	
DWR ID	16394					
Comment Code						
Inspector Comment						
FS_ID:52170 DS_ID:16394 EP_NO: N/A Repair Type: Non-Urgent Crossing Status: Found UCIP Comments: 5/30/2017 WS flap gate showing signs of rusting and deterioration but still appears to be able to function properly. Pipe has been selected to be internally cleaned and inspected as part of the DMP project. (DWR Sutter Yard - A Freitag)11/17/2016 WS flap gate is really rusted and deteriorated but it appears to still function properly. (DWR Sutter Yard - A Freitag)4/26/2016 WS flap gate is really rusted and deteriorated. May need to be replaced. The rest of the crossing appeared in good condition.6/30/2015 Crossing is in good condition. No noticeable issues to be reported.5/28/2014 Same as last inspection.12/4/2013 WS ans LS slopes are in good condition.7/08/2013 Same as last inspsection.4/24/2012 Limited inspection on WS and LS slopes due to dense vegetation. Need photos of cleared WS and LS slopes. This crossing was listed in the USACE Periodic Inspection report as Corp's inspect ID# USACE_CESPK_M13E_2011_p_0251 for no outlet visible on WS. FIELD_STRUCT_DESC: 24-inch corrugated metal drainage pipe through the levee, 11.6 feet below the crown. Flap gate on the waterside (WS) end. Concrete "U" headwalls on both WS and landside (LS). Rusted gate located on the WS (gate stuck). [Additional Reference(s): DWR Levee Log, 1993. USACE Sacramento O&M Manual 519, June 1962 (HLM 22.08)] FS Date: 6/8/2017 10:37:02 AM

Flap gate located on WS.

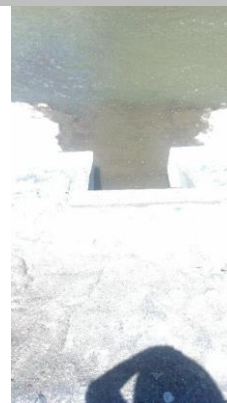
Photo 2 of 3 : UCIP_FA_2018_52175_67496.jpg

View of WS slope looking from WS headwall to levee crown.

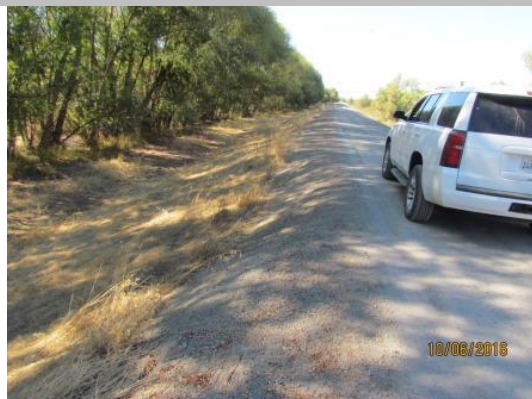
Photo 1 of 1 : FA_2018_MA0013_301_62_20180905_00014.jpg

View of slope instability issue along the landside slope.

LM Start	22.33	Rating **	A/W	Issue No.	62
LM End	22.33	Issue Type +	Ma	Location *	LS
Category	Earthen Levee			GPS Latitude/Longitude	
				Start	End
Item	Slope Stability			39.358419 °	39.358419 °
				-121.875088 °	-121.875088 °
DWR ID	DWR_MA0013_02_s_2016_62				
Comment Code					
S1 : Repair slope instability.					
Inspector Comment
